Testing Built-up and Modified Bitumen Roofs for Hail Damage

IIBEC 2022 - Building for the Future
International Convention and Trade Show

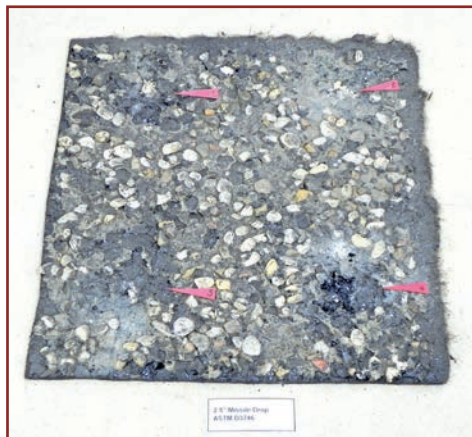
The test results related to surface damage were consistent. The impact from a 2.5 in. (64 mm) missile resulted in surface damage to the samples on both the insulated and noninsulated substrates. The results of the laboratory impact damage to the surface were compared with test samples of roofs that had been damaged by hail and to examples included in Haag Engineering's *Built-up Roofing: A Pictorial Guide*.⁸ The test sample before the missile drop is shown in Fig. 3. The test sample after the missile drop and after the loose gravel was removed is shown in Fig. 4. The red arrows identify the area of impact in Fig. 4.

Figure 4. The test sample after the missile drop and after the loose gravel was removed.

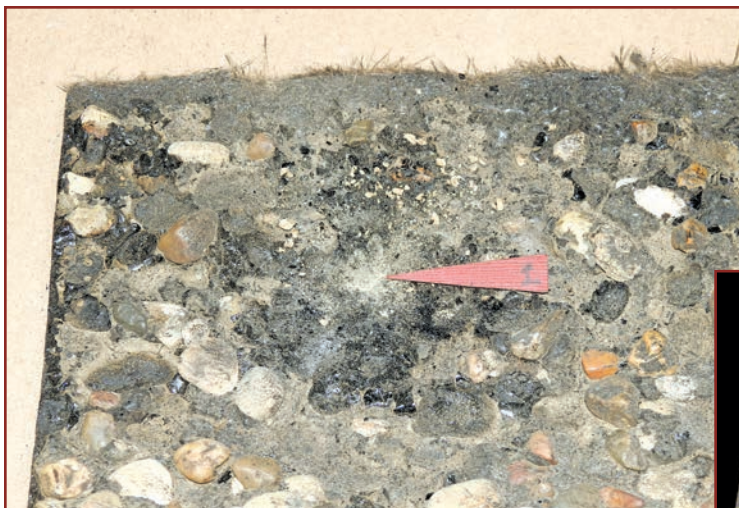
Figure 6. Localized crushing of the asphalt flood coating at the point of impact is shown in this 10-power photograph.

There was localized crushing of the asphalt flood coat at the point of impact, as shown in Fig. 6.

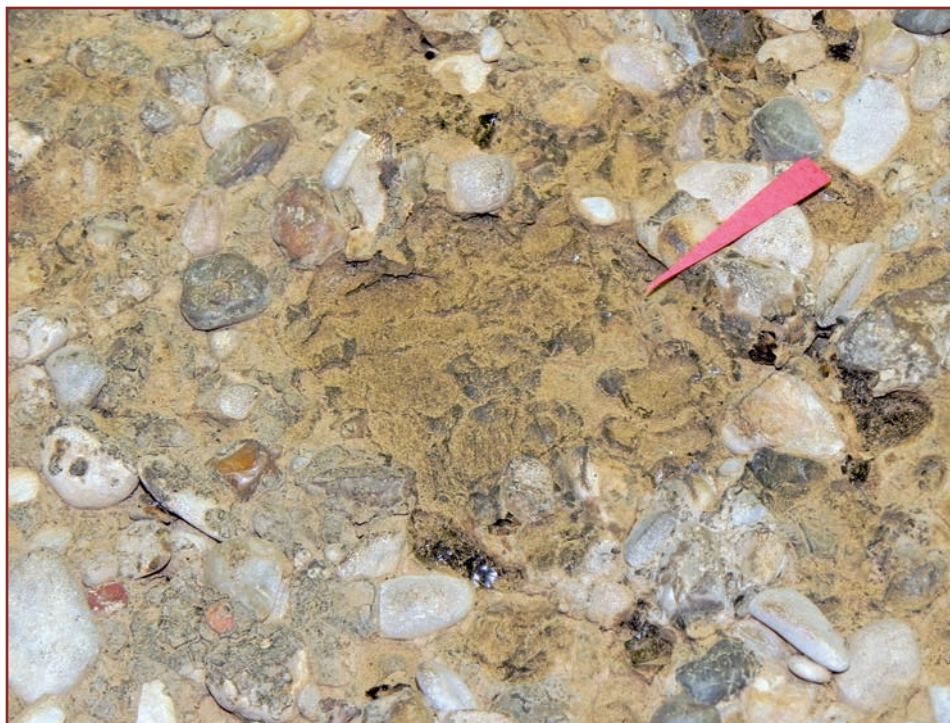
The area of impact in our simulated testing is also consistent with roof samples that we have tested from roofs damaged by hail. Figure 7 shows a test sample taken from a roof that was damaged by hail. The meteorological and physical evidence indicated that the hail was in the 2.5 in. (64 mm) and larger range.

Figure 7. A test sample taken from a roof that was damaged by hail.

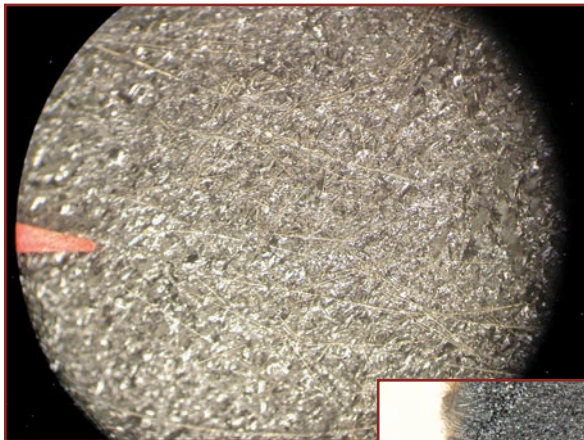
Figure 10. Impact area at 10-power with no evidence of crushed asphalt.

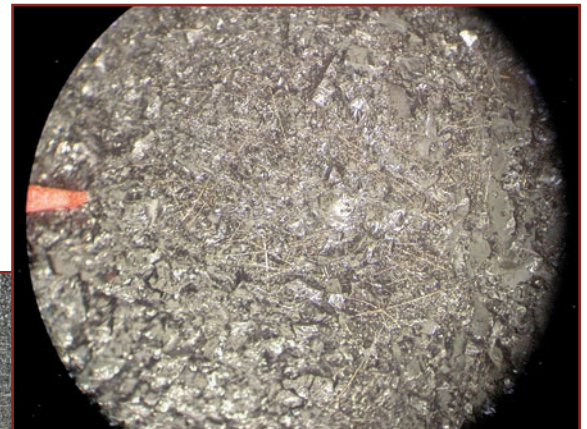
Figure 12. Impact area 4 at 10-power and the crushed interply asphalt at the point of impact.

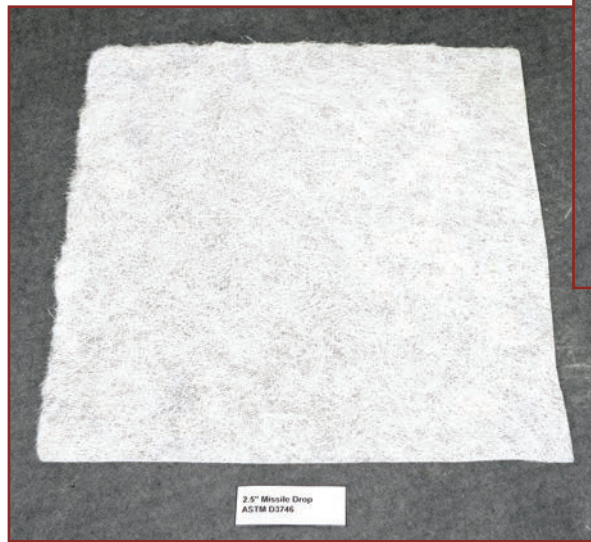
Figure 14. Desaturated bottom ply of felt in the noninsulated (firm substrate) sample.

Figure 14 shows the desaturated bottom ply of felt in the noninsulated (firm substrate) sample. The tension is greatest in the bottom ply, so the bottom ply is the most likely ply to fracture. The tension in the felt was limited by the firm substrate, and there was no fracturing. Also, there was no denting in the fiberglass felts on the insulated and noninsulated sample.

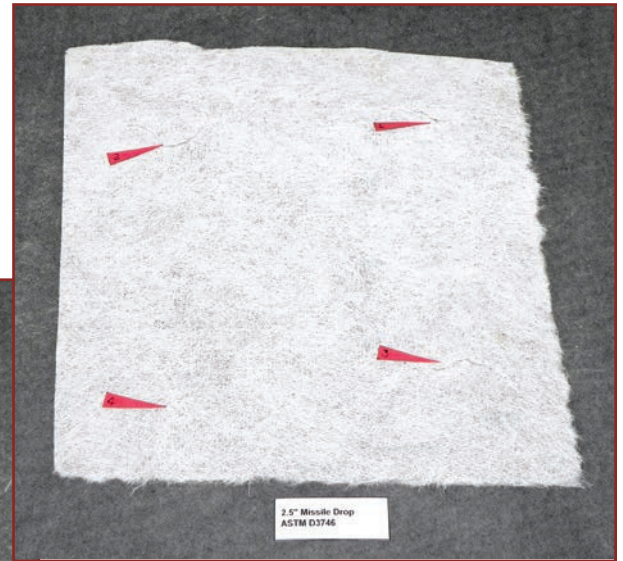
Figure 15. Bottom full ply with impact fractures identified by red arrows.

There were fractures at all impact areas in the insulated sample. Figure 15 shows the bottom full ply with impact fractures identified with the red arrows.

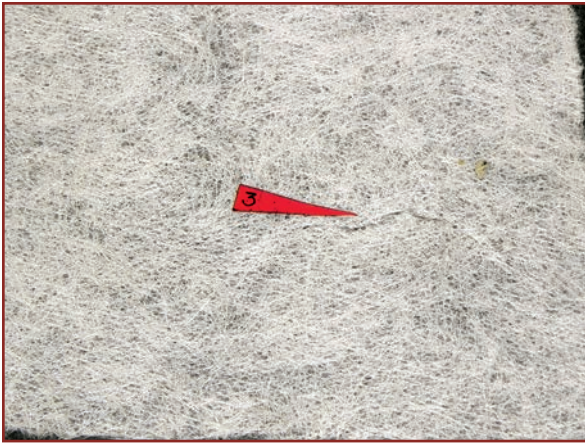
Figure 16 shows a magnified view of the fracture in the felt at impact area 3.

Figure 16. Magnified view of the fracture in the felt at impact area 3.

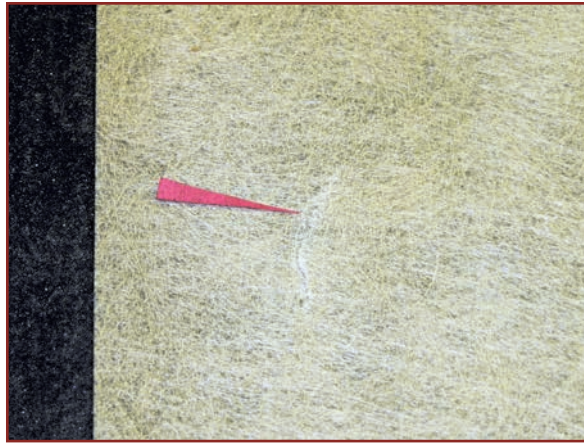
Figure 17. Fractured felts in a test sample from a roof that was damaged by hail.

samples we have tested from roofs damaged by hail. **Figure 17** shows fractured felts in a test sample from a roof that was damaged by hail. This was a roof that was designed by us and was approximately 15 years at the time of the hail event. The hail was in the 2.5 in. (64 mm) and larger range.

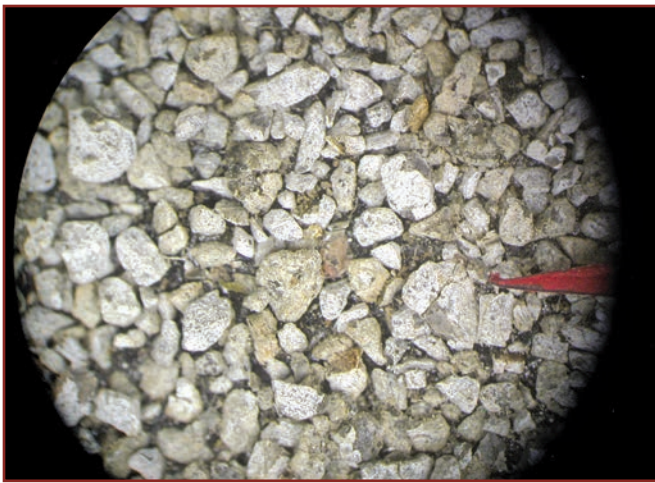
Figure 21. 10-power view of a typical impact area on the insulated sample. There are no discernible displaced granules. There is no evidence of localized crushed granules on the insulated samples.

impact area on the insulated sample. There are no discernible displaced granules. There is no evidence of localized crushed granules on the insulated samples.

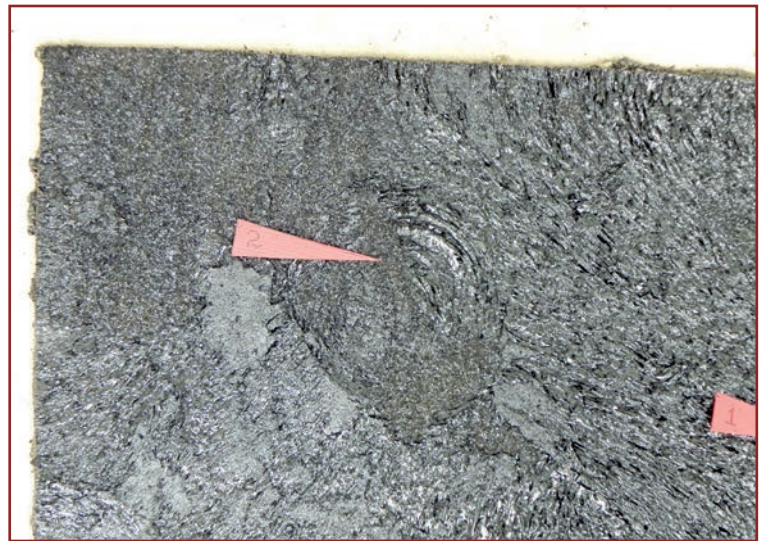
Figure 22. Example of crushed interply on the insulated sample.

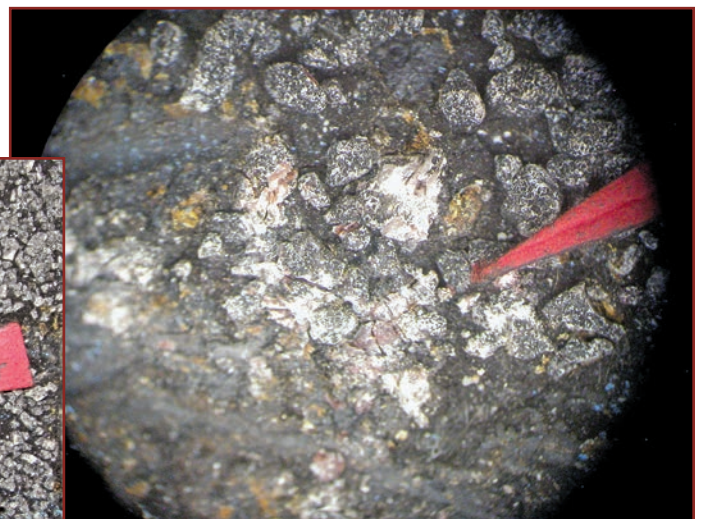
Figure 29 shows impact area 4 at 10-power. The area of impacts on the aged modified bitumen exhibited crushed granules and some displaced granules. It is possible that additional granule loss would occur over time if the sample were exposed to normal weathering.

Figure 29. Impact area 4 at 10-power.

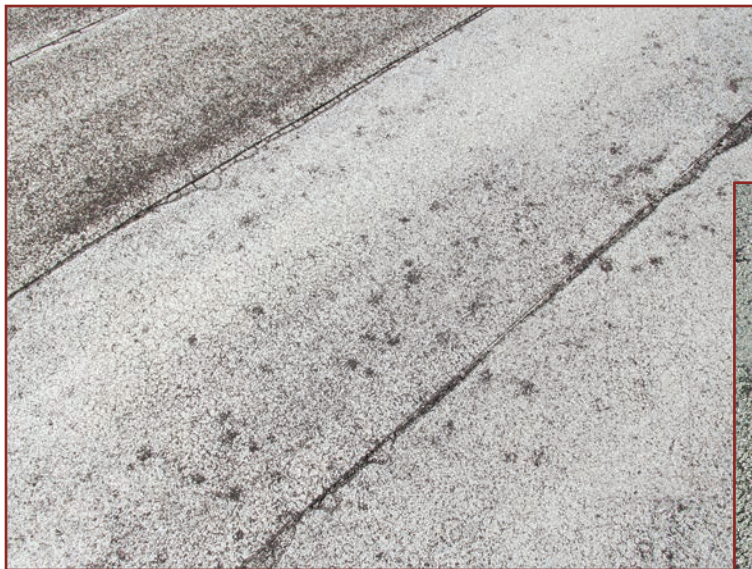
Figure 30. An example of localized granule loss on an aged modified bitumen roof.

We have observed localized granule loss at impacts from actual hail on aged modified bitumen roofs. **Figure 30** shows an example of localized granule loss on an aged modified bitumen roof. The pattern of granule loss was consistent with the random distribution of the large hail that fell and matched the pattern of the larger hail-caused impacts on the air-conditioning units and larger spatter marks.

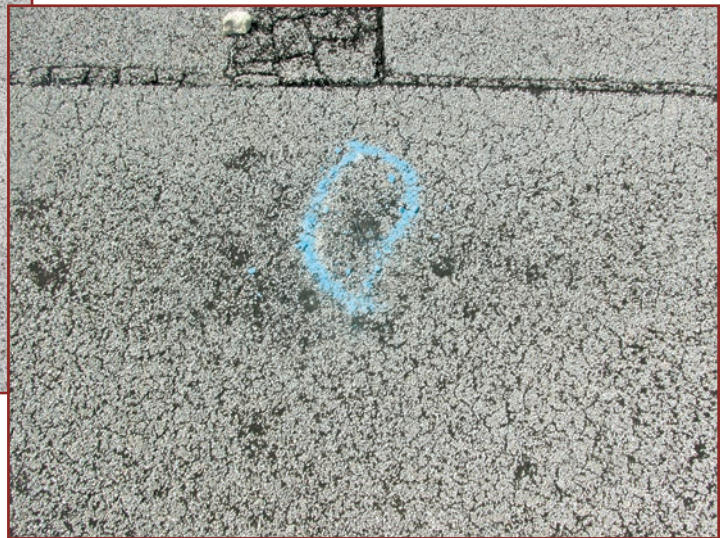
Figure 31 shows a closer view of the hail-caused granule loss on the same project.

Figure 31. A closer view of the hail-caused granule loss on the same project as Fig. 30.

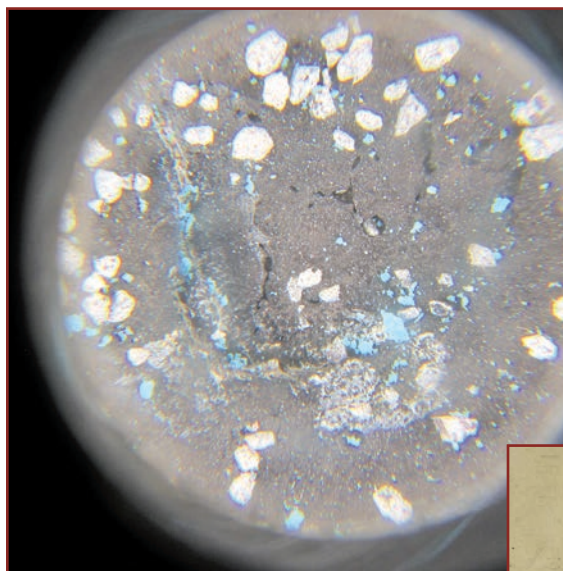
Figure 32 shows the impact at 10-power. There are visible fractures in the surface at the point of impact. Also, note that the surface of the exposed modified bitumen is relatively smooth. There is no evidence of shrinkage cracking or oxidized bitumen typically seen on older modified bitumen roofs.

Figure 32. Impact at 10-power.

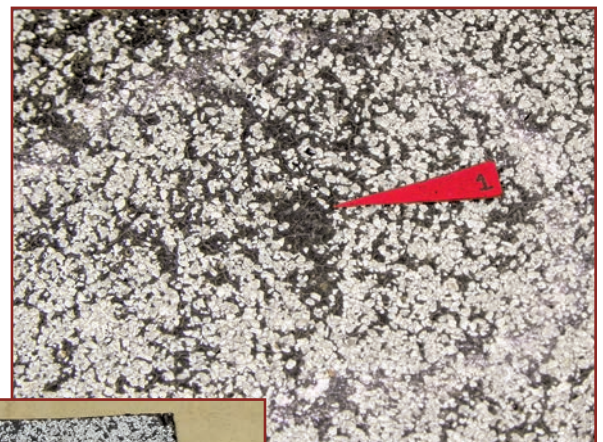
Figure 34 shows a closer view of the point of interest. There is evidence of shrinkage cracking in the surface. There is localized granule loss in areas where the shrinkage cracking has converged. The point of interest is the largest area of localized granule loss visible on the sample.

Figure 34. A closer view of the point of interest.

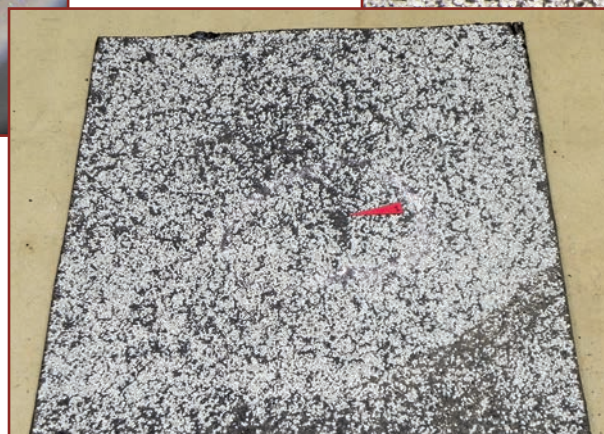
Figure 33. Test sample from a modified bitumen roof with an area of localized granule loss at the point of interest noted.

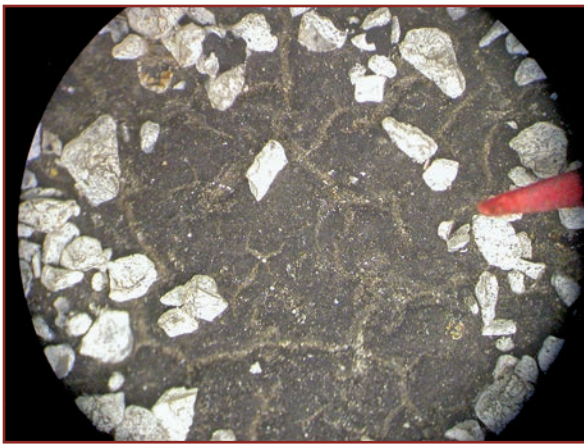
Figure 35. Point of interest at 10-power.

Figure 35 shows the point of interest at 10-power. The oxidized modified bitumen and shrinkage cracking in the modified bitumen surfacing are visible. There is no evidence of impact damage to the surface, and there were no fractures of crushed interply below the point of impact. There was no evidence of any other damage to the sample consistent with hail-caused impact. This type of localized granule loss is often confused with granule loss from hail-caused impact.

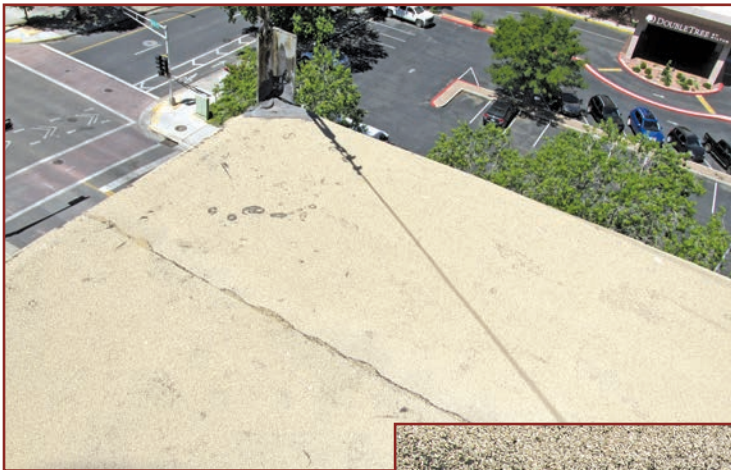
Figure 36. Localized areas of granule loss tend to be in specific areas where birds congregate.

Another type of localized granule loss is related to contaminants such as bird droppings. This type of localized area of granule loss tends to be in specific areas where birds congregate, as shown in **Fig. 36**. This type of localized granule loss is often confused with granule loss from hail-caused impact.

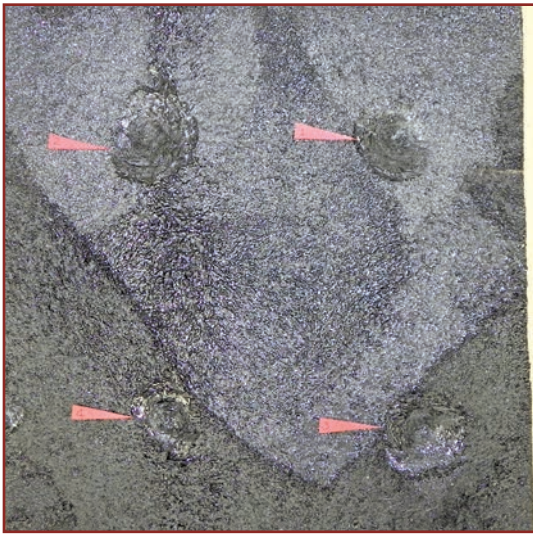
The interply bitumen was examined on the modified bitumen samples. Crushed interply bitumen was observed on the sample at all four areas of impact.

Figure 40. An example of crushed interply on the insulated sample.

Figure 40 shows an example of crushed interply on the insulated sample.

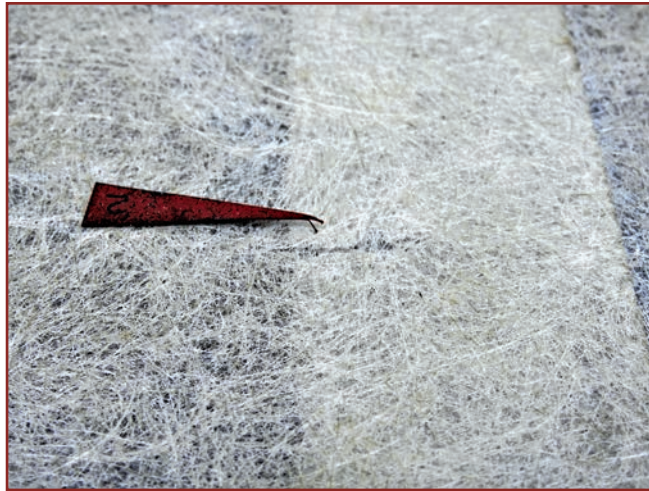
Figure 41. Fractured bottom ply of the membrane.

glass felt. There was no denting or fracturing of the modified bitumen reinforcement. There were fractures in the bottom ply at all four impact areas. **Figure 41** shows the fractured bottom ply of the membrane. The fractures were small and difficult to see without desaturating the felts.

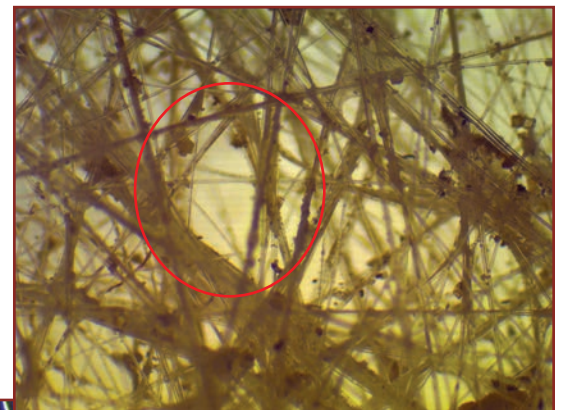
Figure 44 shows the desaturated test area. The individual fibers can be seen. We have seen an increasing number of this type of photograph, which is represented as evidence of hail-caused damage to bituminous roofs. The holes like the one circled in red are often represented as being the result of hail impact. Anomalies resulting from construction or maintenance damage are also often represented as evidence of hail-caused damage. It is important to distinguish normal surface anomalies and normal holes in felts from actual hail-caused impact damage.

Figure 44. Desaturated test area.
