IIBEC 2022 - Building for the Future

Testing Built-up and Modified Bitumen Roofs for Hail Damage

Stephen L. Patterson, RRC, PE

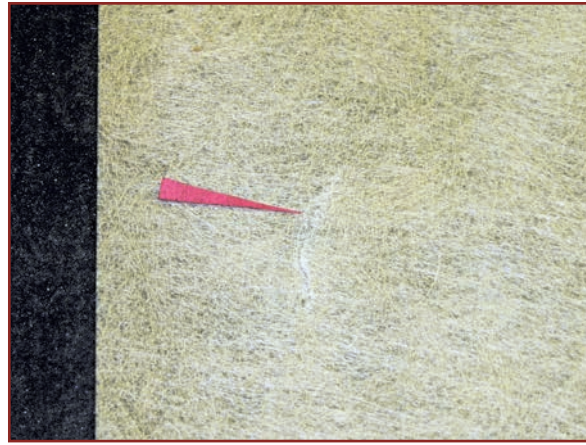
Figure 17. Fractured felts in a test sample from a roof that was damaged by hail.

samples we have tested from roofs damaged by hail. **Figure 17** shows fractured felts in a test sample from a roof that was damaged by hail. This was a roof that was designed by us and was approximately 15 years at the time of the hail event. The hail was in the 2.5 in. (64 mm) and larger range.

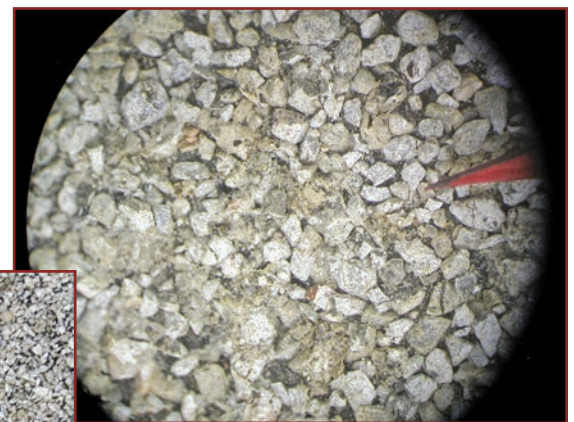
Figure 20 shows a 10-power view of impact area 1. There are no discernible displaced granules. The change in color is the result of localized crushing of the granules at the point of impact.

Figure 20. 10-power view of impact area 1. There are no discernible displaced granules. The change in color is the result of localized crushing of the granules at the point of impact.

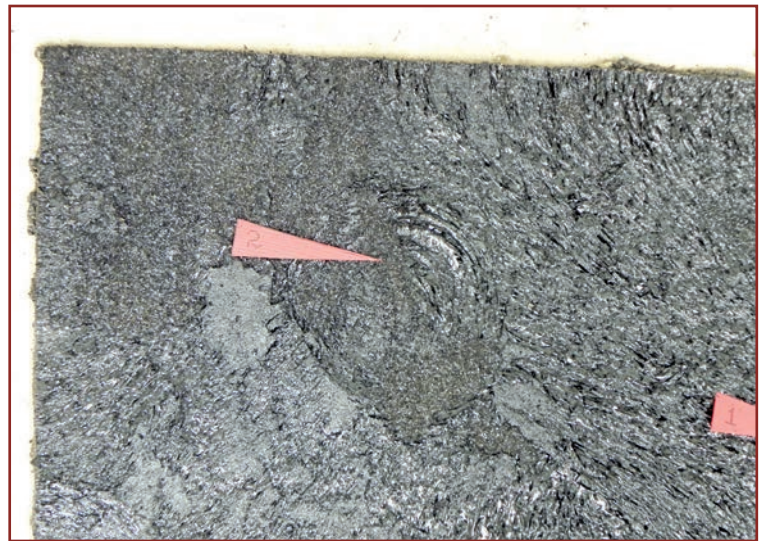
Figure 22. Example of crushed interply on the insulated sample.

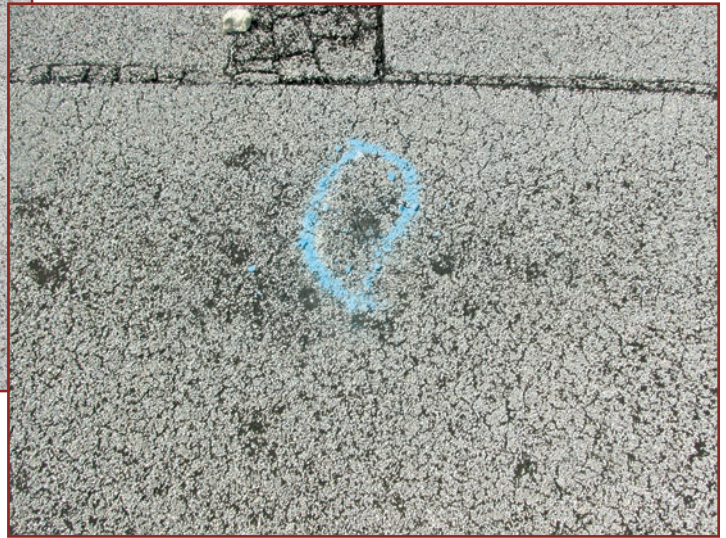
Figure 31 shows a closer view of the hail-caused granule loss on the same project.

Figure 31. A closer view of the hail-caused granule loss on the same project as Fig. 30.

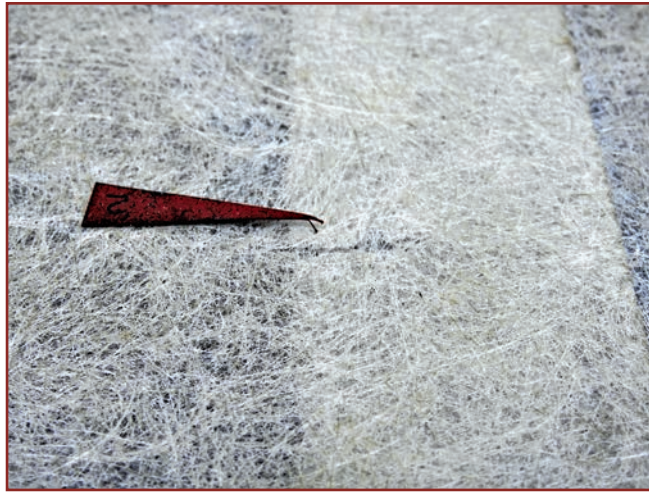
Figure 41. Fractured bottom ply of the membrane.

glass felt. There was no denting or fracturing of the modified bitumen reinforcement. There were fractures in the bottom ply at all four impact areas. **Figure 41** shows the fractured bottom ply of the membrane. The fractures were small and difficult to see without desaturating the felts.
