Testing Built-up and Modified Bitumen Roofs for Hail Damage

IIBEC 2022 - Building for the Future
International Convention and Trade Show

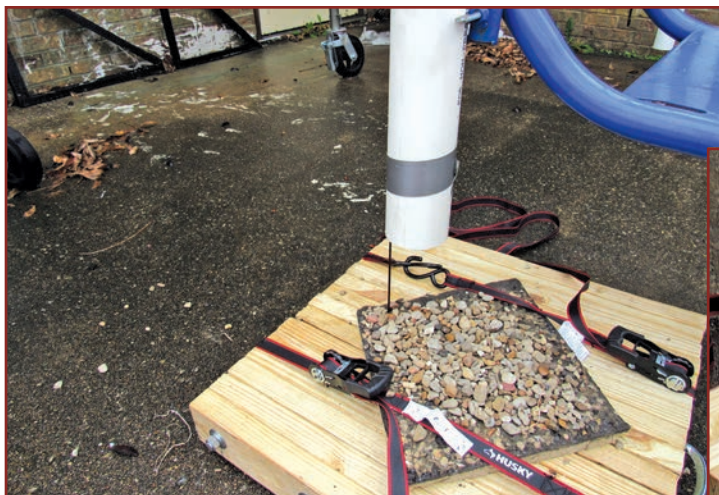
Figure 1. A test sample positioned on the platform.

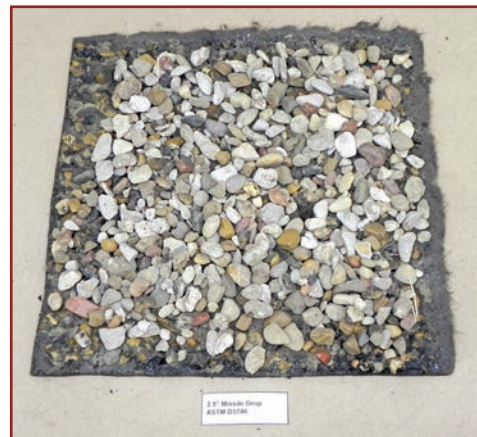
Figure 3. The test sample before the missile drop.

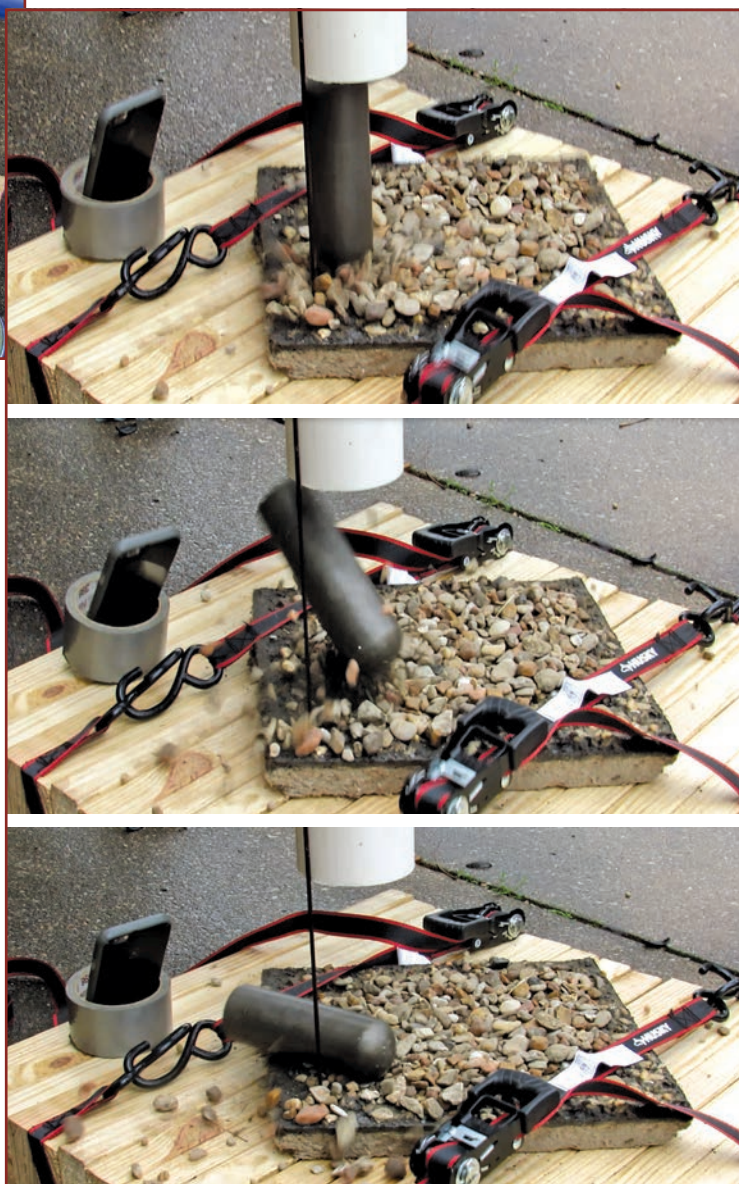
Figure 5. The test sample after the missile drop showing crushed gravel at point of impact.

The areas of impact were very similar on all tests. There was a general displacement of the imbedded aggregate and exposure of the asphalt flood coat. The aggregate at the point of impact was crushed at some of the impacts (Fig. 5). In no case did the impact result in aggregate being driven into the sample, affecting the felts below. The crushed aggregate was likely the result of using a steel missile rather than an ice ball for testing, as hail typically shatters on impact and steel does not.

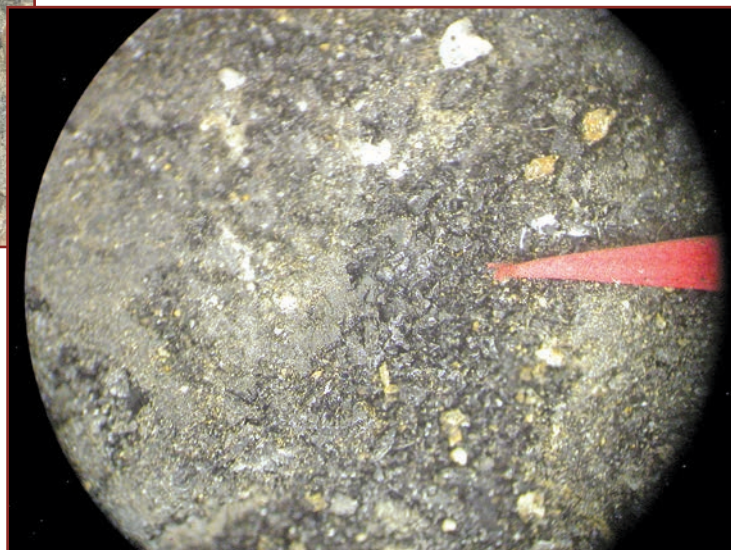
The area of impact in our simulated testing is also consistent with roof samples that we have tested from roofs damaged by hail. Figure 7 shows a test sample taken from a roof that was damaged by hail. The meteorological and physical evidence indicated that the hail was in the 2.5 in. (64 mm) and larger range.

Figure 7. A test sample taken from a roof that was damaged by hail.

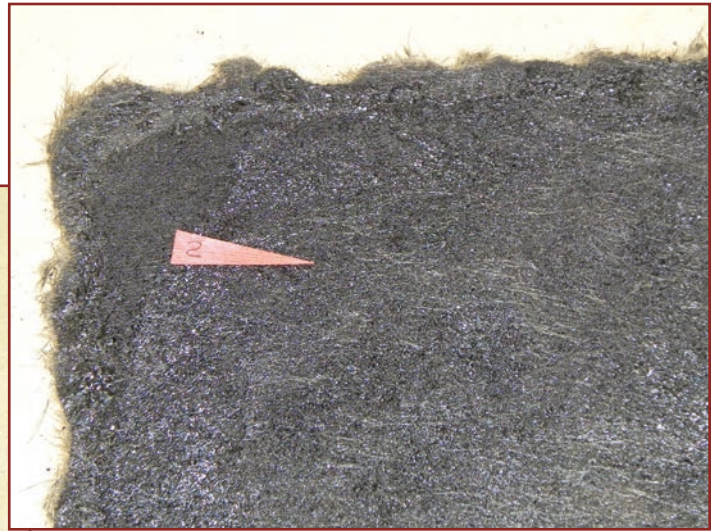
Figure 8. The back side of the top ply of felt, which was partial lap-ply.

bitumen was observed at each area of impact on the insulated samples. Crushed interply was observed at some of the impact areas on the noninsulated samples. **Figure 8** shows the back side of the top ply of felt, which was partial lap-ply. The sample was only impacted by test drops 1 and 2. There was no evidence of crushed interply at this level within the sample.

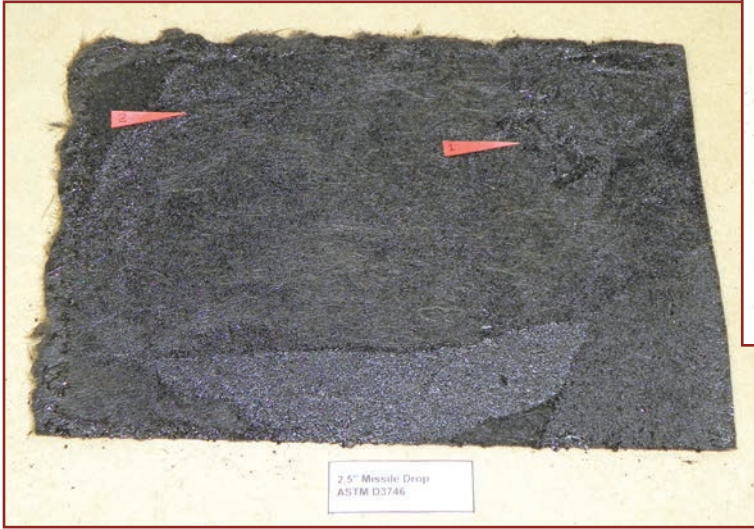
Figure 9. Close-up of impact 2 with no evidence of crushed or disturbed interply.

Figure 9 shows a close up of impact 2 with no evidence of crushed or disturbed interply.

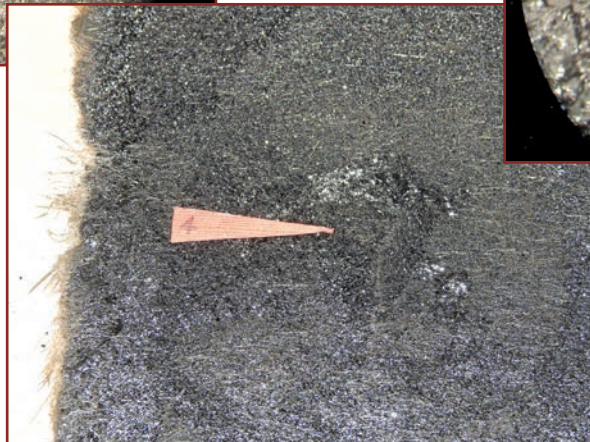
There was evidence of crushed interply in the lower layers of felt. **Figure 11** shows impact area 4 on the back of the first full ply.

Figure 11. Impact area 4 on the back of the first full ply.

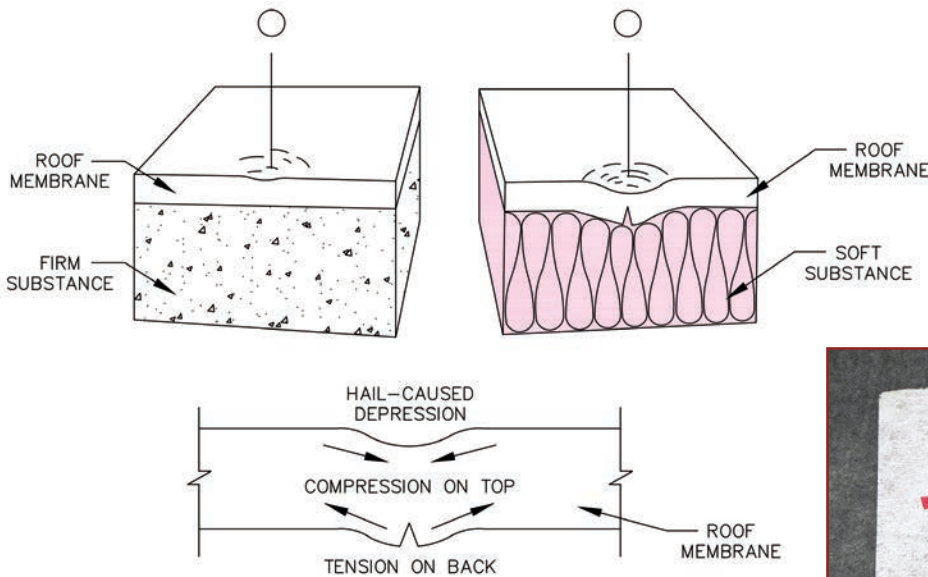
Figure 13. The softer substrate allows for more deflection in the membrane, resulting in tension in the bottom layers of the felts. Figure: Adapted from Haag Engineering's *Built-up Roofing: A Pictorial Guide*.

Our test results confirm the importance of the substrate in the hail resistance of bituminous roofs. In general, the softer the substrate (typically insulated), the more susceptible the roof is to hail damage. Impact from very large hail can cause localized deflection in the membrane at the point of impact. Figure 13 illustrates how the softer substrate allows for more deflection in the membrane, resulting in tension in the bottom layers of the felts.

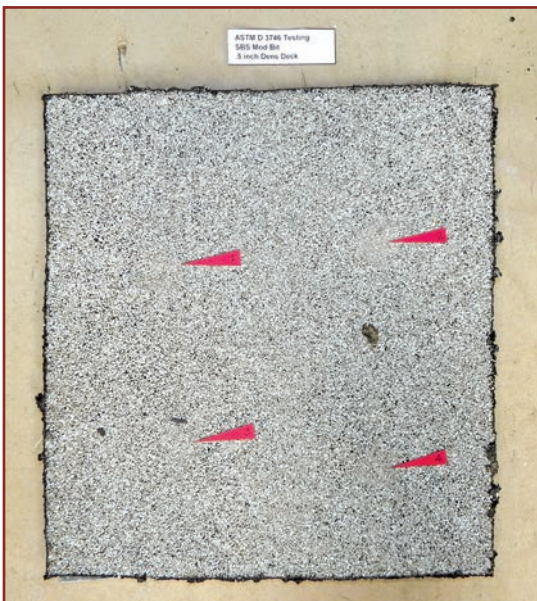
Figure 18 shows the new modified bitumen sample on noninsulated substrate after the sample was impacted by the four missile drops.

Figure 18. The new modified bitumen sample on noninsulated substrate after the sample was impacted by the four missile drops.

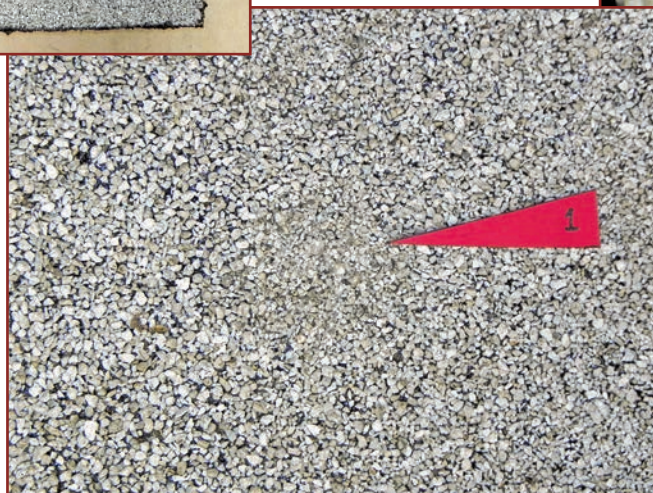
Figure 19 shows a closer view of impact area 1. There is a slight difference in the color of the granules.

Figure 19. A closer view of impact area 1. There is a slight difference in the color of the granules.

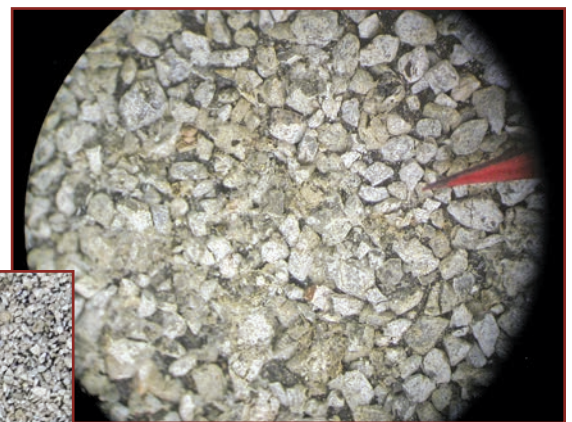
Figure 20 shows a 10-power view of impact area 1. There are no discernible displaced granules. The change in color is the result of localized crushing of the granules at the point of impact.

Figure 20. 10-power view of impact area 1. There are no discernible displaced granules. The change in color is the result of localized crushing of the granules at the point of impact.

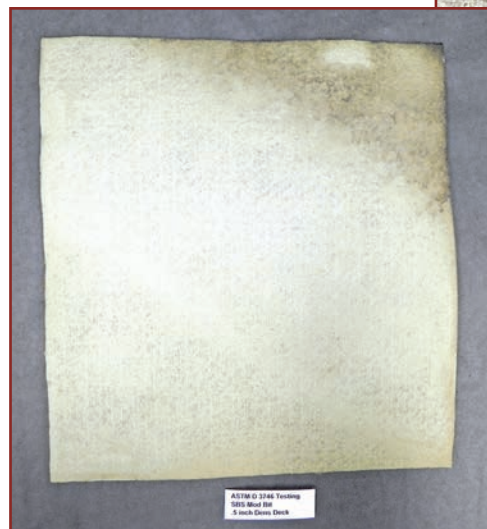
The second ply was fiberglass asphalt felt. There were fractures in the fiberglass felt at all four missile drops on both the insulated and noninsulated samples. It should be noted that there was a depression at the area of impact in the gypsum cover board, which resulted in more tension in the bottom ply than the built-up samples on the wood testing table. **Figure 24** shows a fracture in the bottom ply (fiberglass felt) on the noninsulated sample. The fractures on the insulated samples were more pronounced than on the noninsulated samples.

Figure 24. Fracture in the bottom ply (fiberglass felt) on the noninsulated sample.

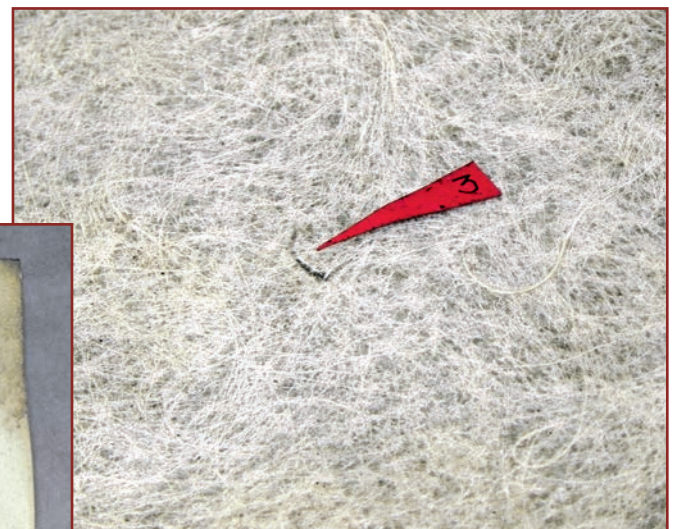
The modified bitumen membrane had a dual-carrier mat with a combination of polyester and fiberglass reinforcement. **Figure 23** shows the dual-carrier mat with no

Figure 23. Dual-carrier mat with no fractures or denting.

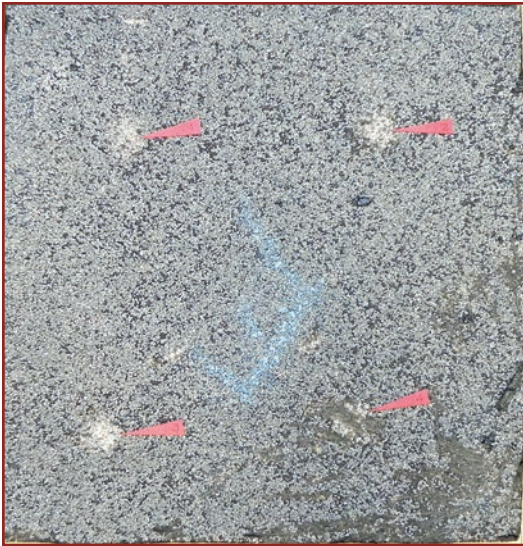
Figure 25. Aged modified bitumen roof on the noninsulated substrate after the sample was impacted by the four missile drops.

The test results related to surface damage to the granule-surfaced modified bitumen samples were similar to results for the noninsulated new modified bitumen sample, with the exception that there was some granule displacement at the point of impact on the aged sample. **Figure 25** shows the aged modified bitumen roof on the noninsulated substrate after the sample was impacted by the four missile drops.

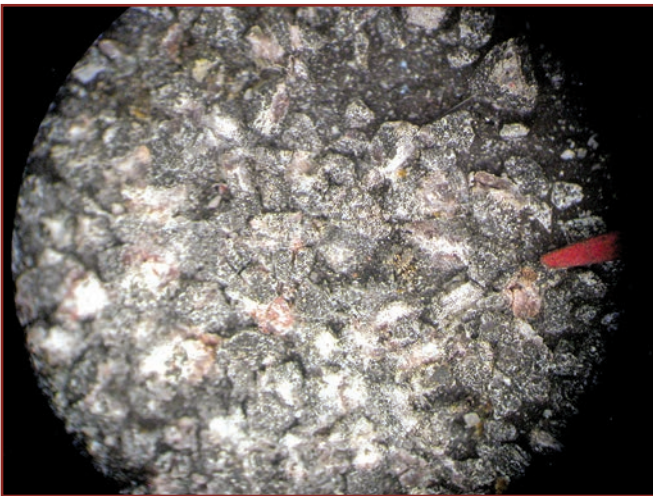
Figure 26. Close-up of impact area 3.

Figure 26 shows a close-up of impact area 3. There are crushed granules similar to the crushed granules on the new modified bitumen sample on

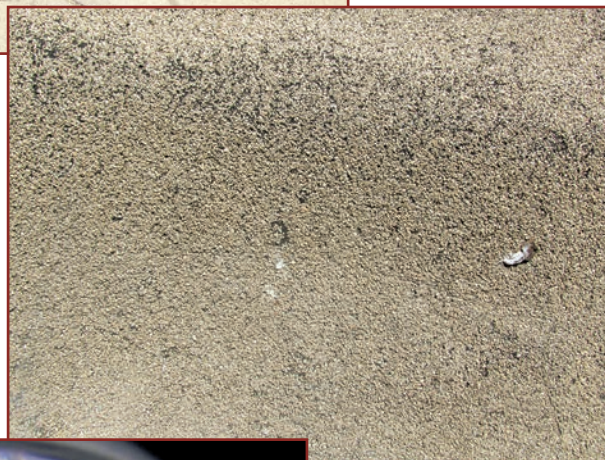
Figure 36. Localized areas of granule loss tend to be in specific areas where birds congregate.

Another type of localized granule loss is related to contaminants such as bird droppings. This type of localized area of granule loss tends to be in specific areas where birds congregate, as shown in **Fig. 36**. This type of localized granule loss is often confused with granule loss from hail-caused impact.

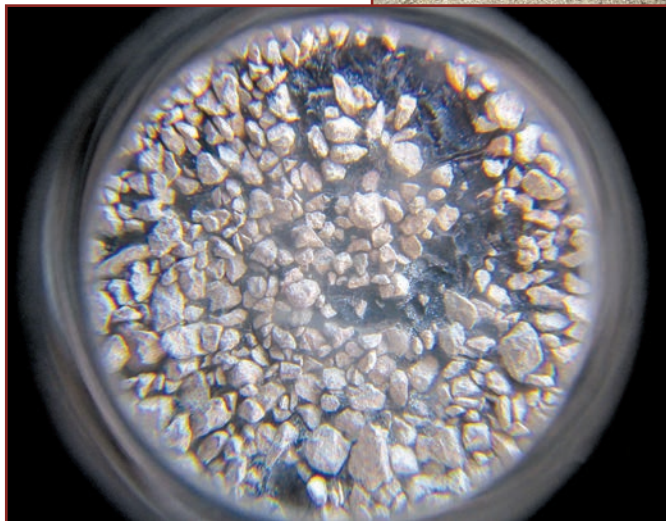
Figure 37. A closer view of granule loss of localized granule loss occurring as a result of contaminants from bird droppings.

Figure 37 shows a closer view of granule loss of localized granule loss occurring as a result of contaminants from bird droppings.

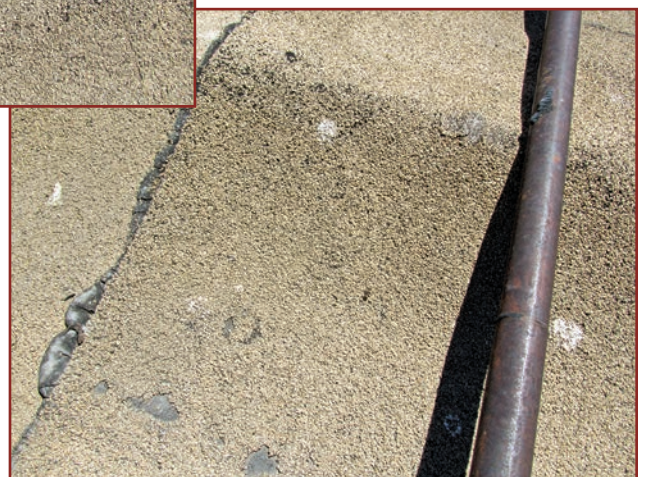
Figure 38 shows the progression of granule loss occurring as a result of the bird droppings. Remnants of the bird droppings are visible. The granules typically continue to come off over time.

Figure 39 shows the progression of granule loss from small semicircular areas of granule loss to complete circular granule loss.

Figure 38. Progression of granule loss occurring as a result of the bird droppings.

Figure 39. Progression of granule loss from small semicircular areas of granule loss to complete circular granule loss.

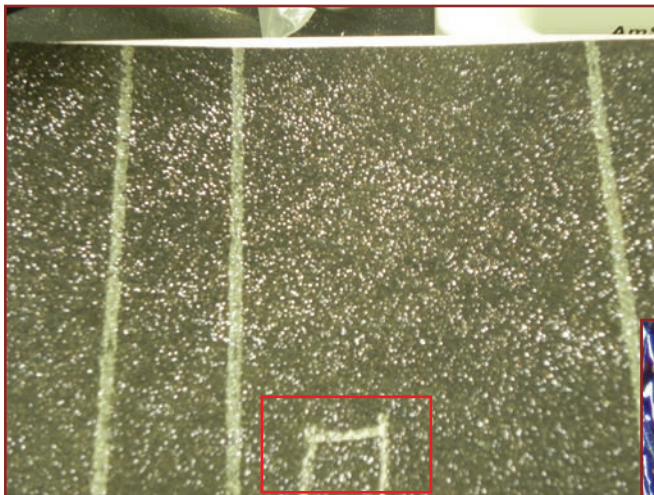
Figure 42. A 12 × 12 in. sample was removed and placed on a light table illustrating the normal holes in the new felt. Note: 1 in. = 25.4 mm.

new roll of Type IV fiberglass felt. A 12 × 12 in. (305 × 305 mm) sample was removed and placed on a light table, illustrating the normal holes in the new felt, as shown in **Fig. 42**.

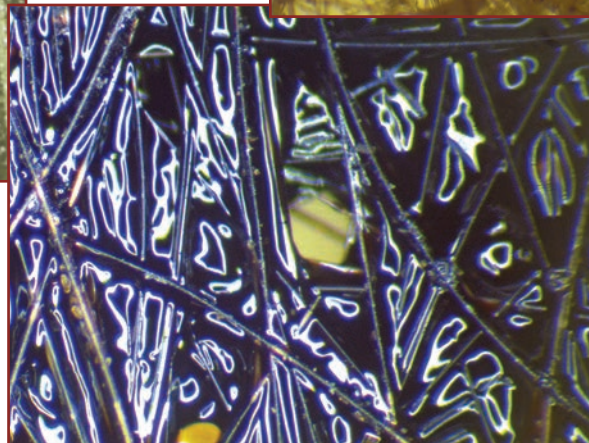
Figure 44 shows the desaturated test area. The individual fibers can be seen. We have seen an increasing number of this type of photograph, which is represented as evidence of hail-caused damage to bituminous roofs. The holes like the one circled in red are often represented as being the result of hail impact. Anomalies resulting from construction or maintenance damage are also often represented as evidence of hail-caused damage. It is important to distinguish normal surface anomalies and normal holes in felts from actual hail-caused impact damage.

Figure 44. Desaturated test area.
