IIBEC 2022 - Building for the Future

Testing Built-up and Modified Bitumen Roofs for Hail Damage

Stephen L. Patterson, RRC, PE

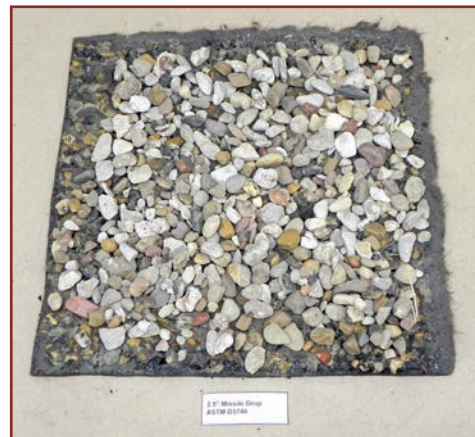
Figure 3. The test sample before the missile drop.

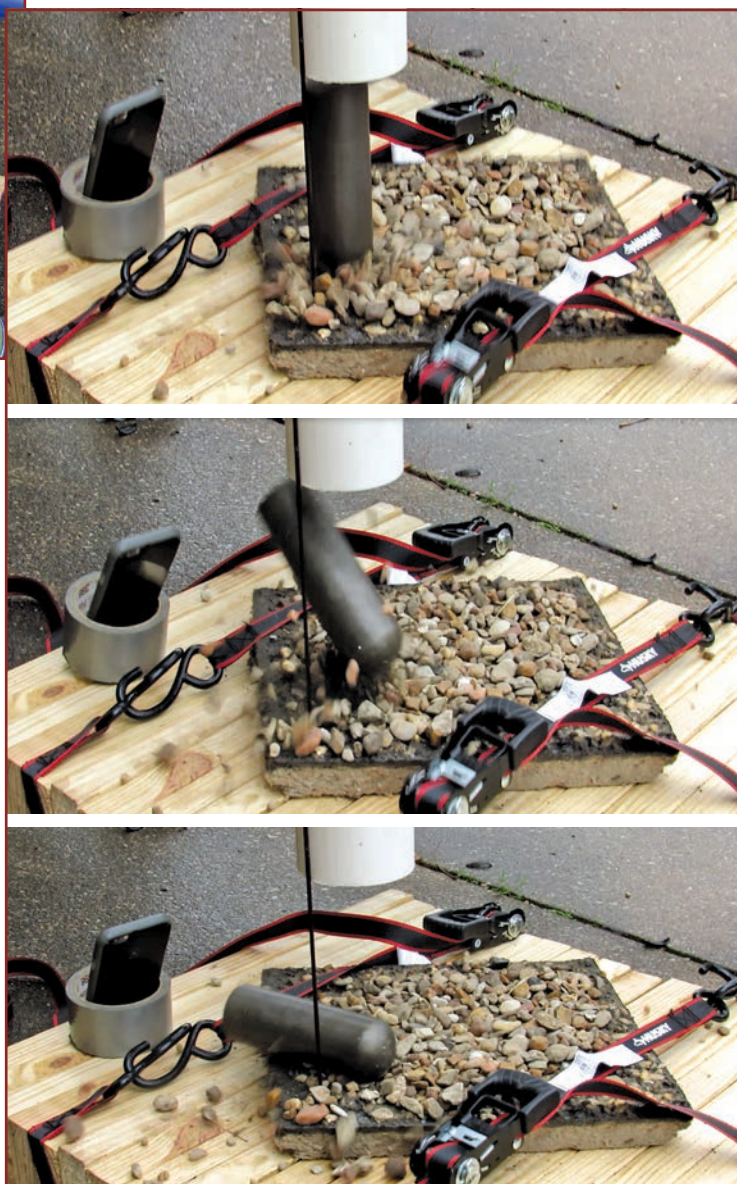
Figure 5. The test sample after the missile drop showing crushed gravel at point of impact.

The areas of impact were very similar on all tests. There was a general displacement of the imbedded aggregate and exposure of the asphalt flood coat. The aggregate at the point of impact was crushed at some of the impacts (Fig. 5). In no case did the impact result in aggregate being driven into the sample, affecting the felts below. The crushed aggregate was likely the result of using a steel missile rather than an ice ball for testing, as hail typically shatters on impact and steel does not.

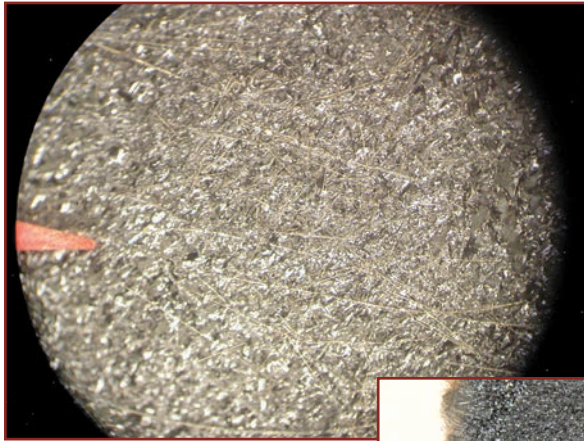
Figure 10. Impact area at 10-power with no evidence of crushed asphalt.

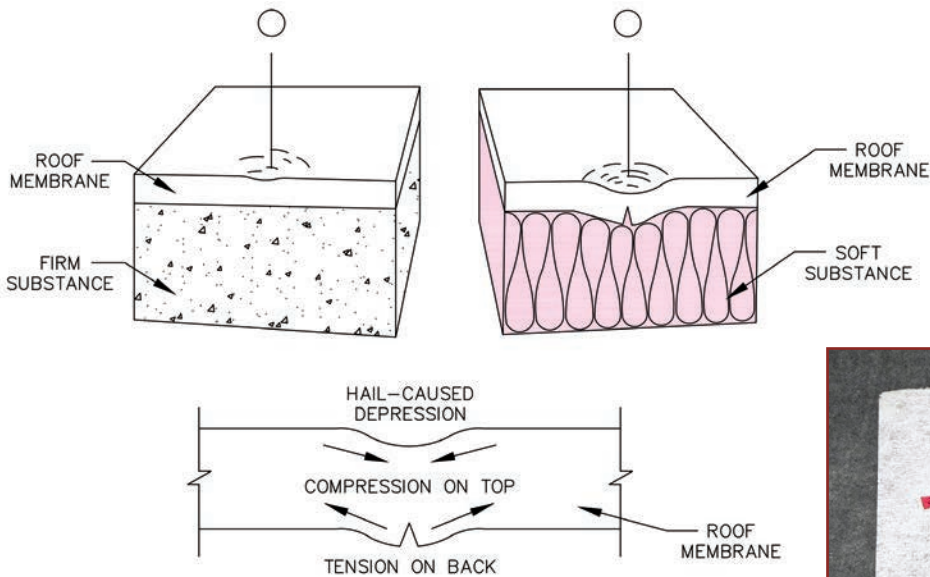
Figure 13. The softer substrate allows for more deflection in the membrane, resulting in tension in the bottom layers of the felts. Figure: Adapted from Haag Engineering's *Built-up Roofing: A Pictorial Guide*.

Our test results confirm the importance of the substrate in the hail resistance of bituminous roofs. In general, the softer the substrate (typically insulated), the more susceptible the roof is to hail damage. Impact from very large hail can cause localized deflection in the membrane at the point of impact. Figure 13 illustrates how the softer substrate allows for more deflection in the membrane, resulting in tension in the bottom layers of the felts.

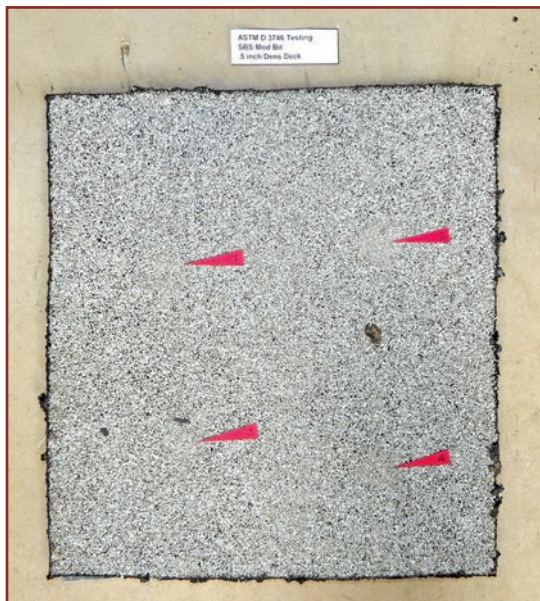
Figure 18 shows the new modified bitumen sample on noninsulated substrate after the sample was impacted by the four missile drops.

Figure 18. The new modified bitumen sample on noninsulated substrate after the sample was impacted by the four missile drops.

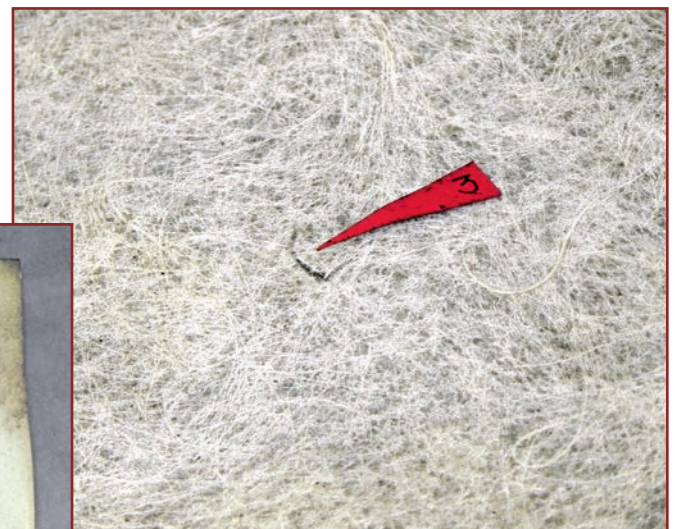
The modified bitumen membrane had a dual-carrier mat with a combination of polyester and fiberglass reinforcement. **Figure 23** shows the dual-carrier mat with no

Figure 23. Dual-carrier mat with no fractures or denting.

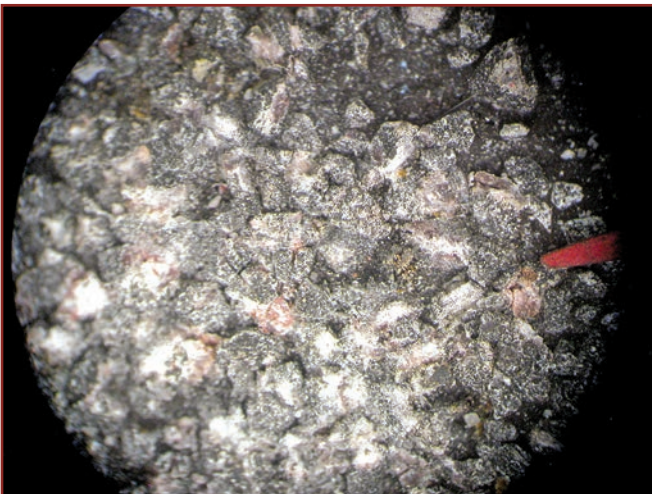
Figure 26. Close-up of impact area 3.

Figure 26 shows a close-up of impact area 3. There are crushed granules similar to the crushed granules on the new modified bitumen sample on

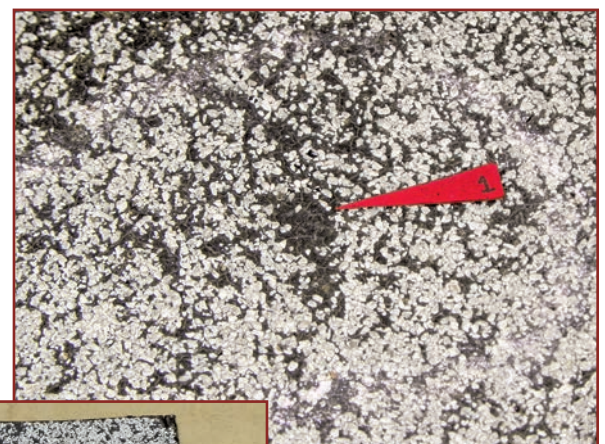
Figure 33 shows a test sample from a modified bitumen roof with an area of localized granule loss at the point of interest noted. This type localized granule loss is also often confused with localized granule loss from hail impact. In some cases, a close examination of the area of granule loss will exhibit signs of weathering, as shown in Fig. 33, indicating that the gran-

Figure 33. Test sample from a modified bitumen roof with an area of localized granule loss at the point of interest noted.

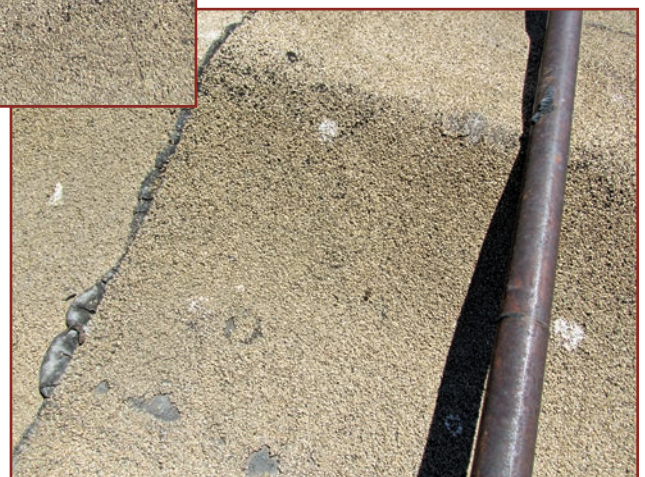
Figure 39. Progression of granule loss from small semicircular areas of granule loss to complete circular granule loss.

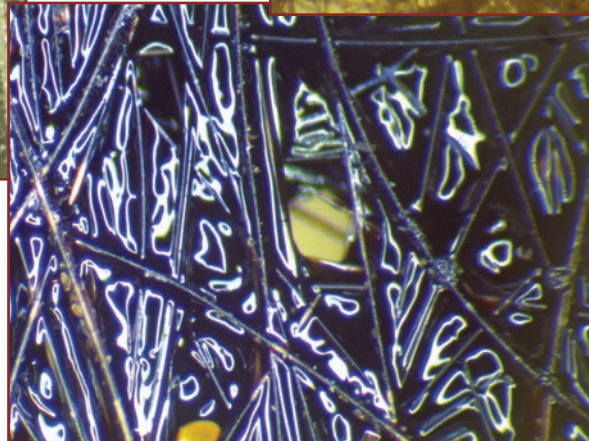
Figure 44 shows the desaturated test area. The individual fibers can be seen. We have seen an increasing number of this type of photograph, which is represented as evidence of hail-caused damage to bituminous roofs. The holes like the one circled in red are often represented as being the result of hail impact. Anomalies resulting from construction or maintenance damage are also often represented as evidence of hail-caused damage. It is important to distinguish normal surface anomalies and normal holes in felts from actual hail-caused impact damage.

Figure 44. Desaturated test area.
